# A natural history perspective of the forests, wetlands and surface waters of Sandy Lake (Bedford) & Environs

Presentation by David Patriquin  
to Sackville Rivers Association

Dec 6, 2018

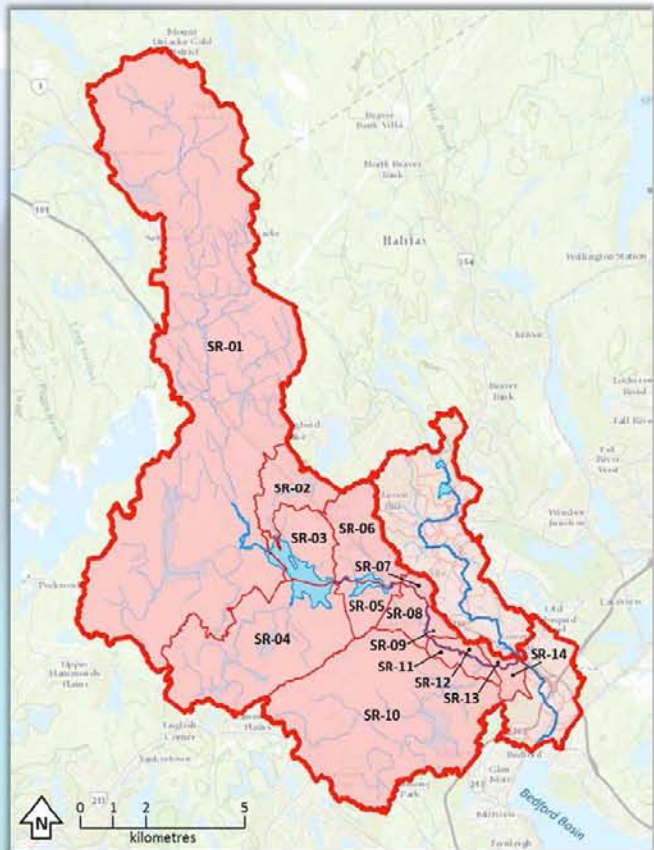
Figure 2.2: Sub-Watershed Delineation of the Upper Reach of the Sackville River (Background Map  
Source: Esri World Topographic Map)

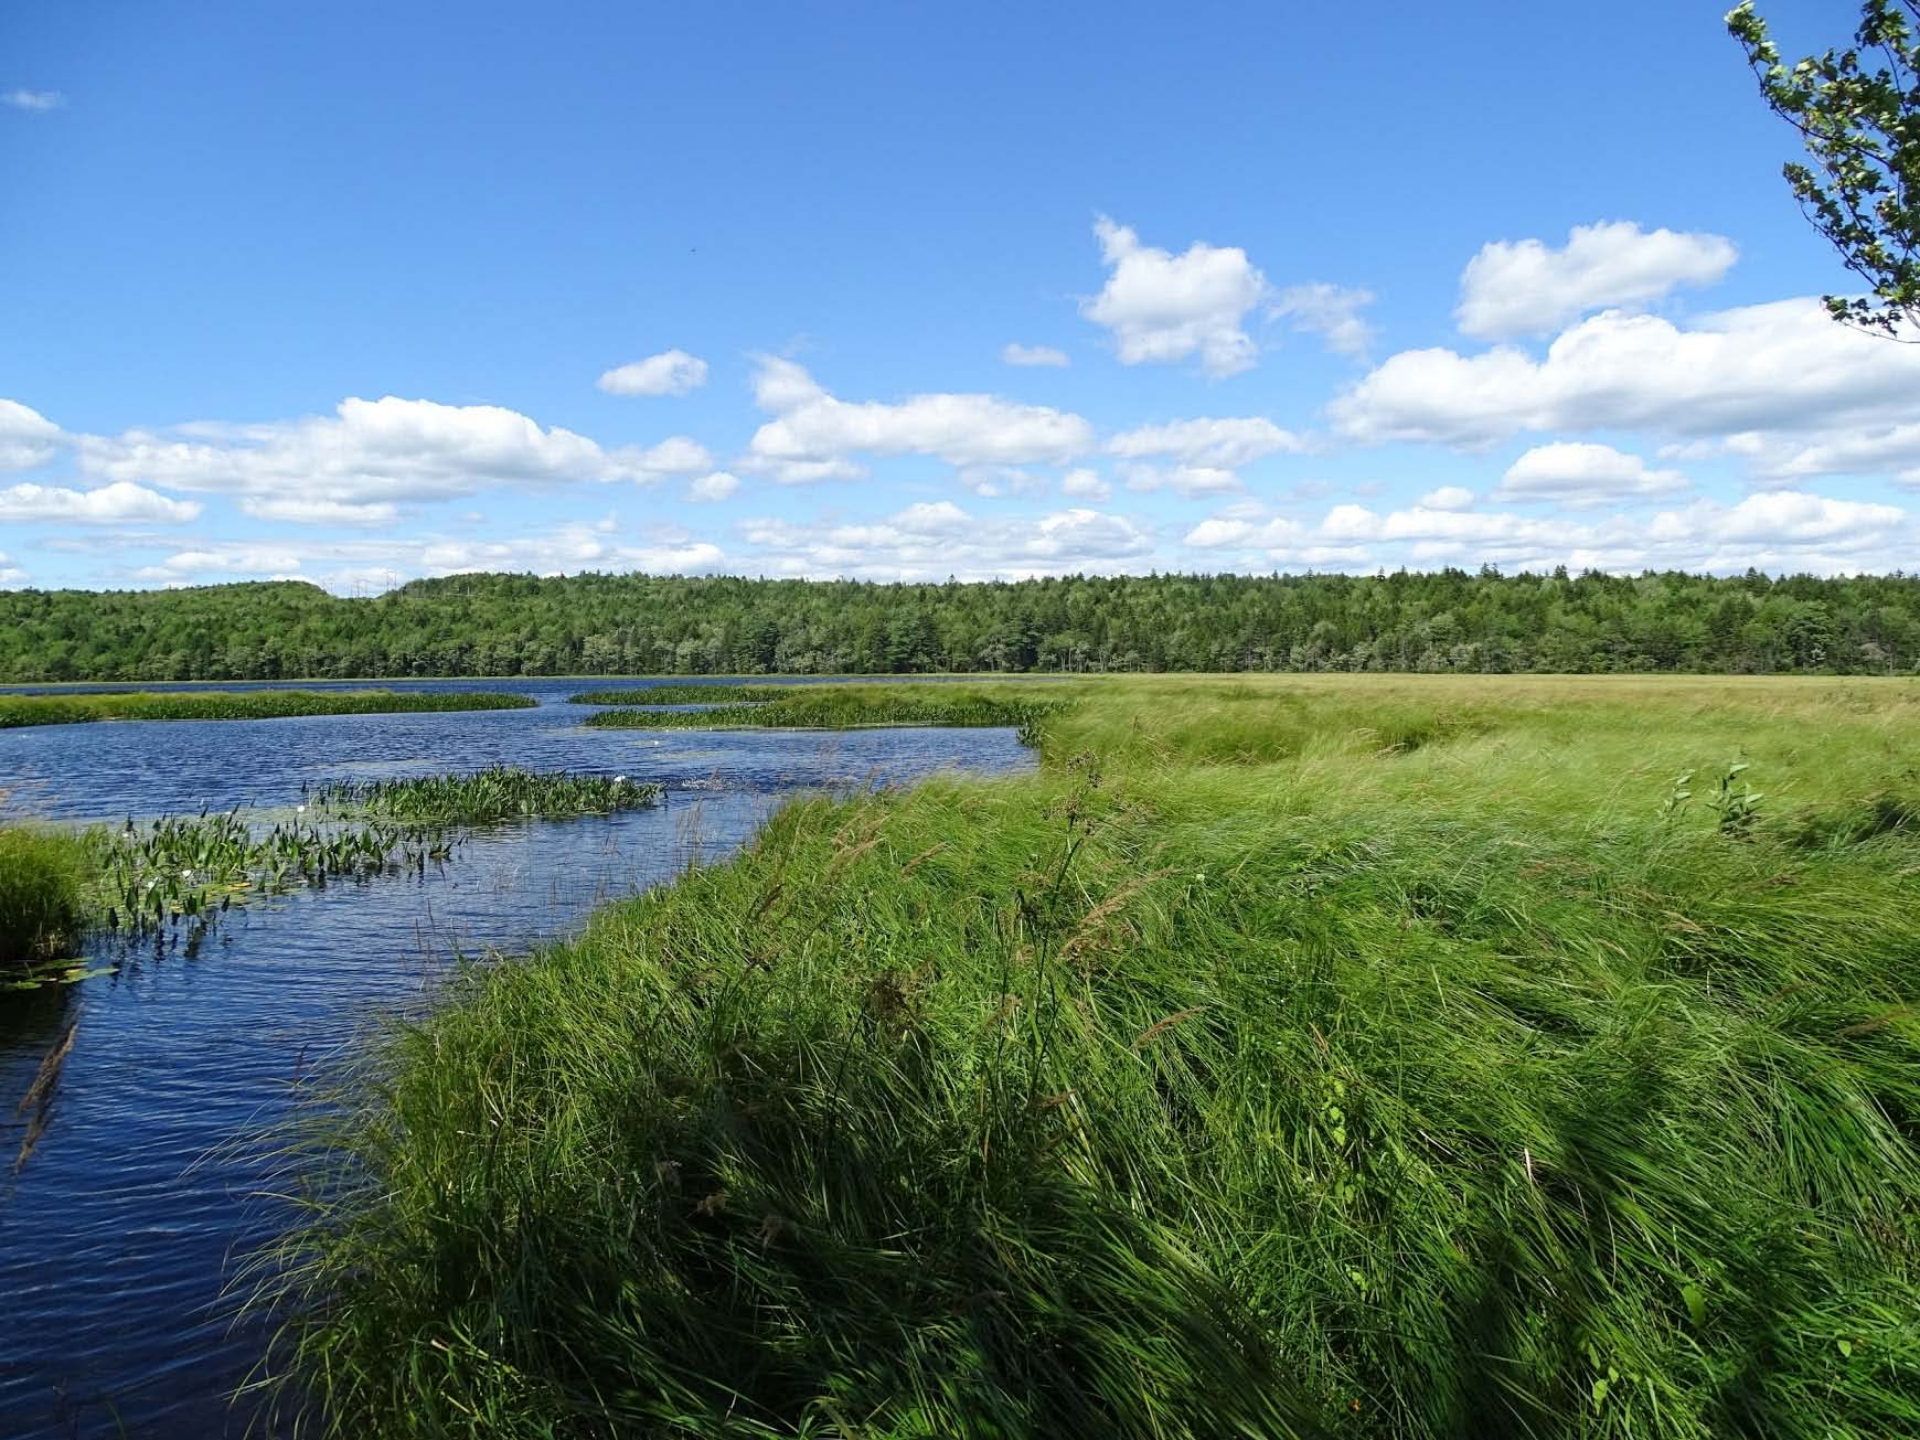
LOCATIONS OF BEAVER LODGE & DAMS ON UPPER PEVERILL'S  
BROOK, AUG 3, 2018

Lodge &  
Dam1

Dam2

Dam3

Dam4

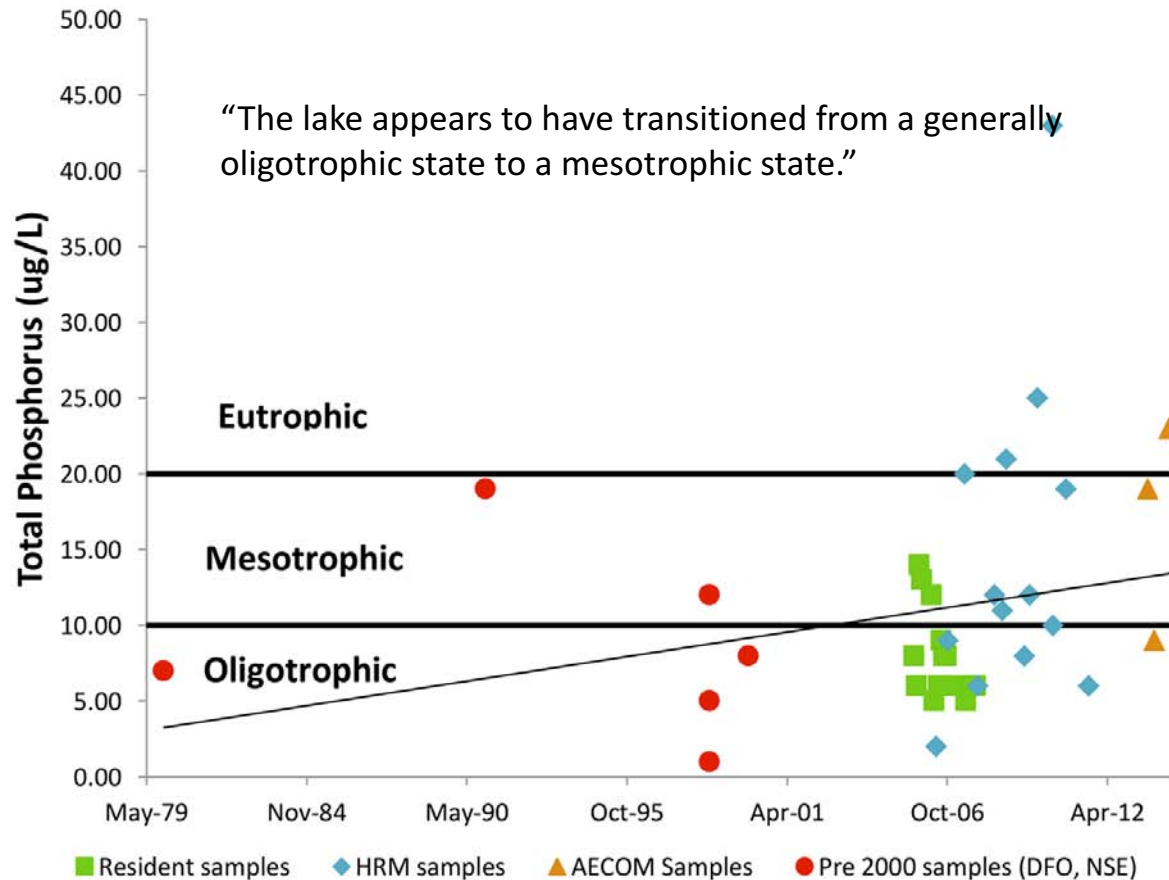
Figure 9: Sandy Lake Total Phosphorus - All Samples

Table 11. Water Quality Objectives and Early Warning Values for Total Phosphorus

Lake	Trophic State Objective	Numerical Objective	Early Warning	Evaluation
Sandy Lake	Mesotrophic	< 18 µg/L	15µg/L	Based on 3 year running average
Marsh Lake	Mesotrophic	< 15.5 µg/L	13 µg/	Based on 3 year running average.

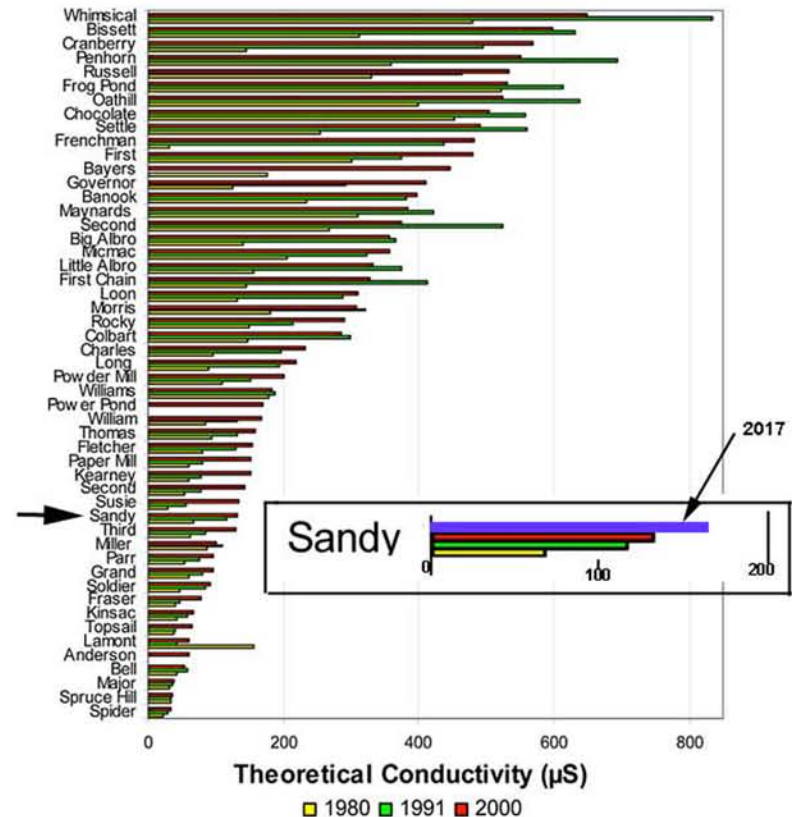
Modified Fig 4 from Synoptic Water Quality Survey Of Selected Halifax Regional Municipality Lakes On 28-29 March 2000. P. Clement et al., 2007. Canadian Technical Report of Fisheries and Aquatic Sciences NNNN

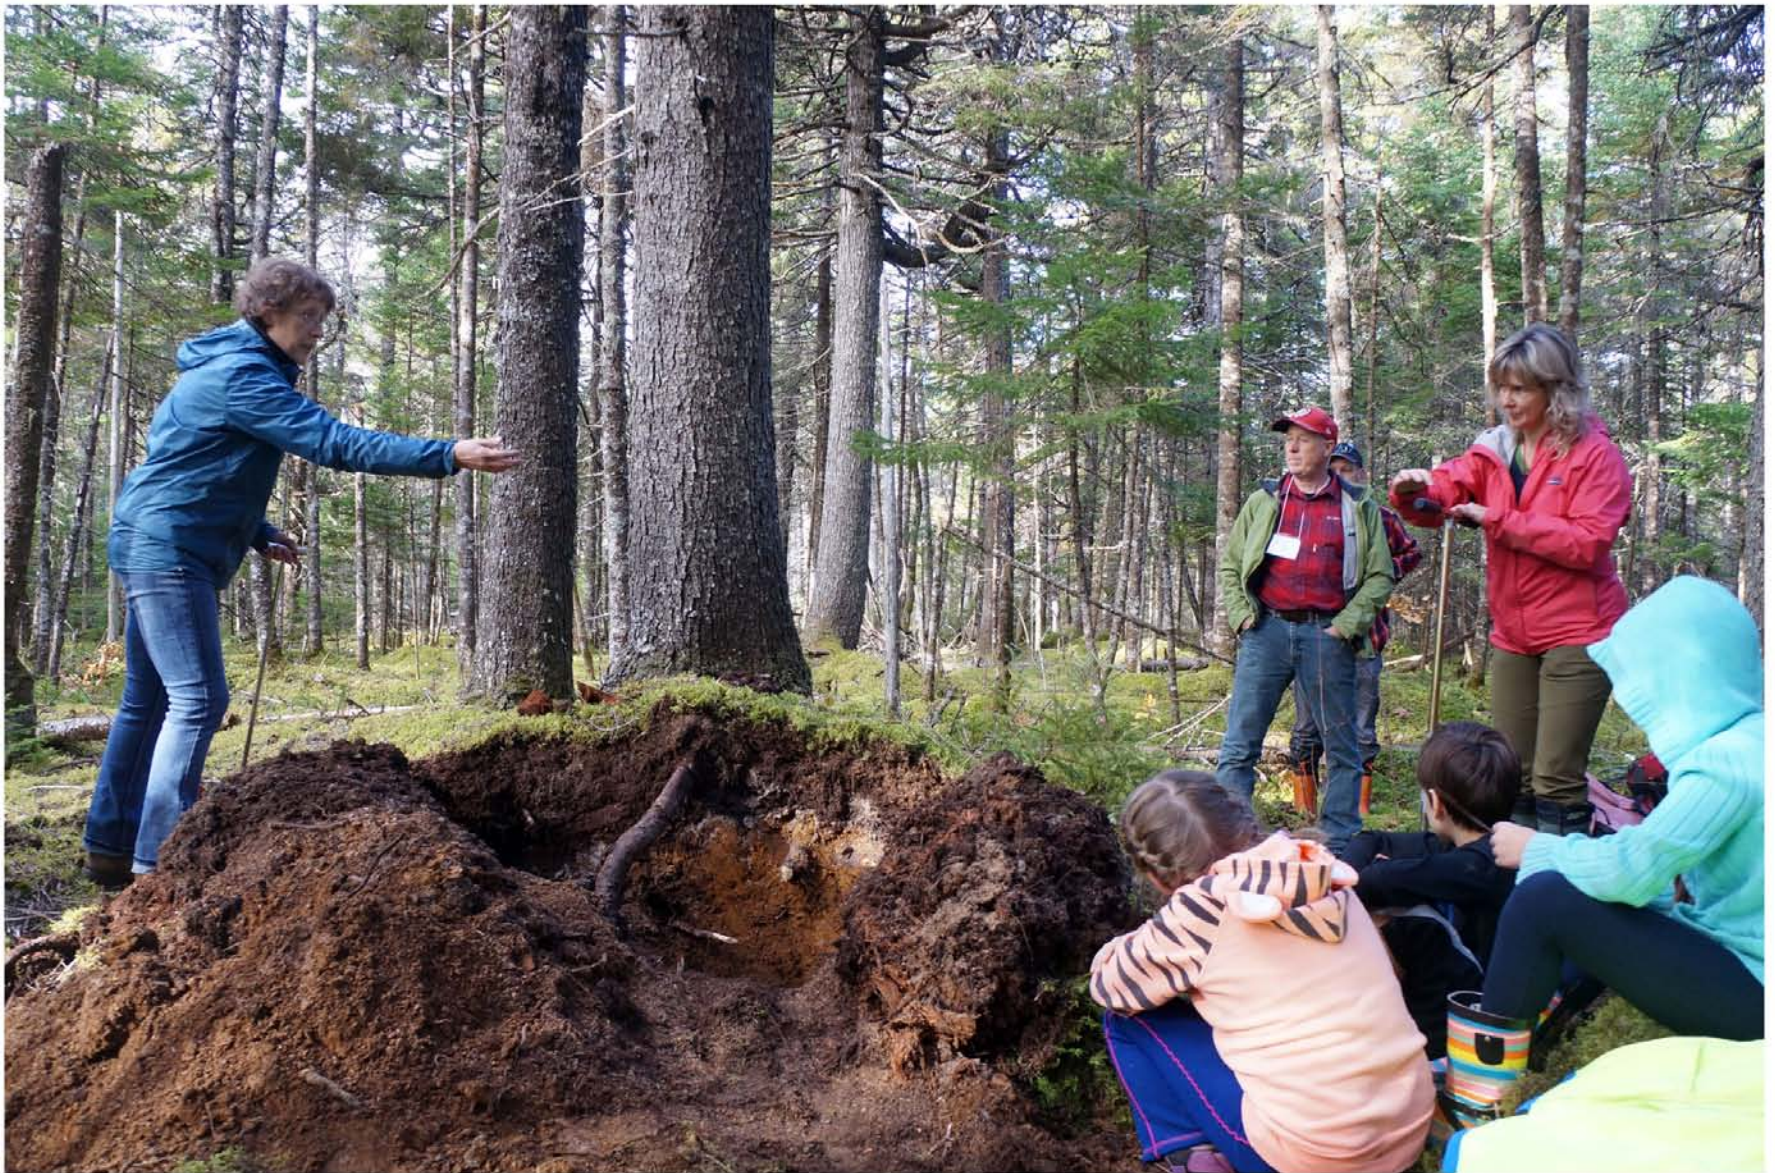
**Dr. Elena Ponomarenko shows participants in the MTRI Old Forest Conference (Oct 19-21, 2016) how to read the forest floor to uncover past disturbances and forest types**

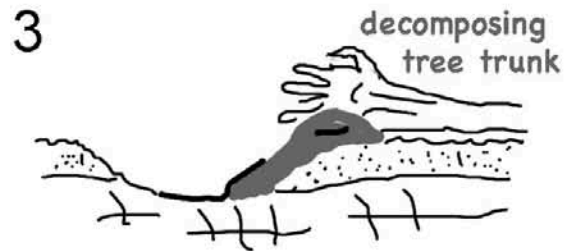
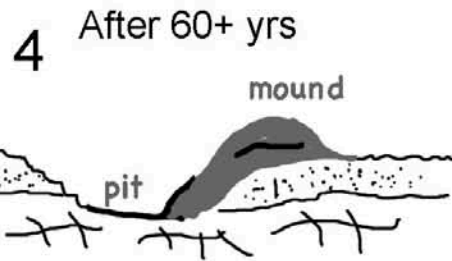
Diagram after Łukasz Pawlik 2013. The role of trees in the geomorphic system of forested hillslopes — A review *Earth-Science Reviews* 126: 250-265

"This "pit and mound" topography occurs when old big trees are blown down, their roots upended. The mound is created by the exposed root ball, the hollow is where it once was.

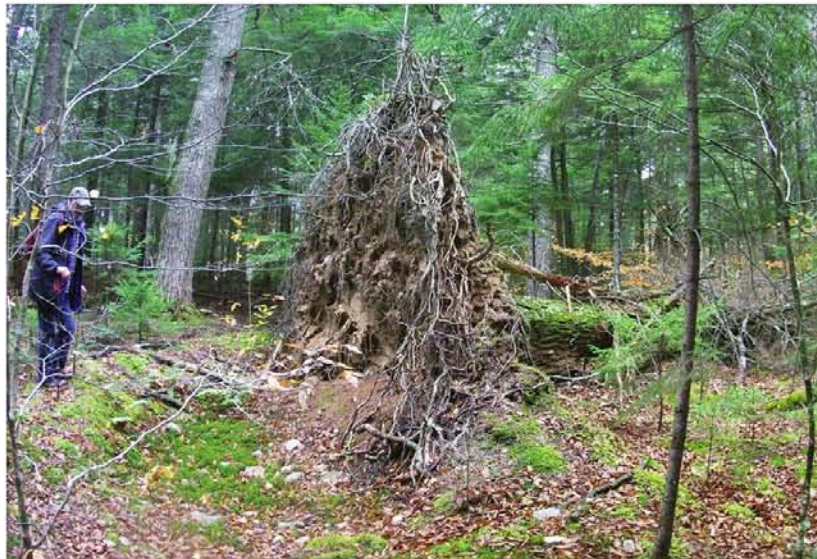
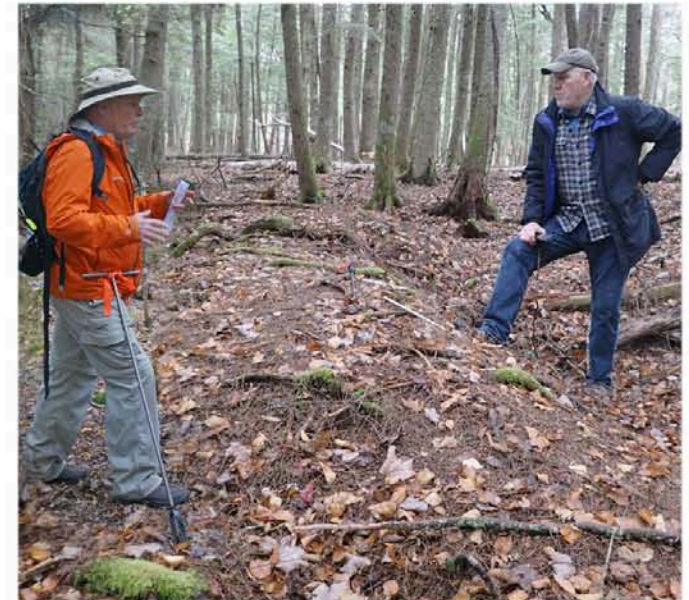
**Mound density and widths at  
three old forest sites at Sandy Lake**

**Mound width** is the dimension perpendicular to the inferred direction of the uprooted tree stem. i.e. it is the longest dimension of a mound.

**Mound density** is the number of mounds traversed over three, 25 meter transects, i.e. over 75 m all told. The 3 transects began at a single pit. The first or mid-transect was oriented in the "guesstimated" average direction of windfalls; the second transect was oriented approximately 30 degrees to one side of the first transect and the third at approximately 30 degrees to the other side. Mounds were classified as either H (high, approx. 50 cm +) or L (low, typically 10-30 cm height) as they were crossed.

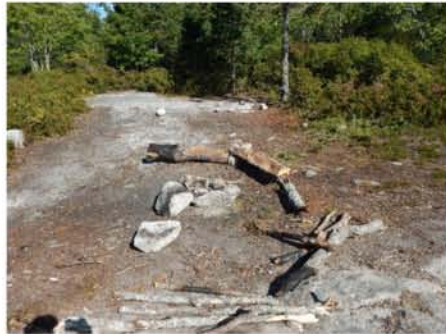
Ongoing degradation near Lake Frederick, Sep 2015

- Trail hardening over wet spots
- Leave No Trace ethic
- Stewardship program
- More “wildland” trails in HRM!

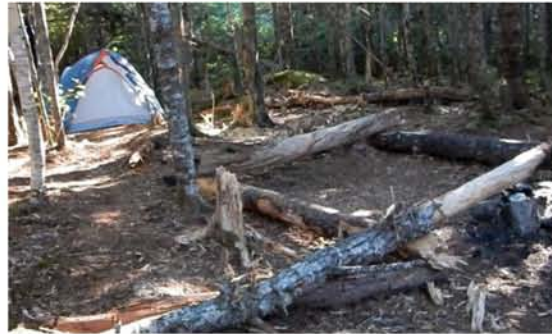
Brand new campsite on trail near Cranberry Lake Portage, Oct 2015

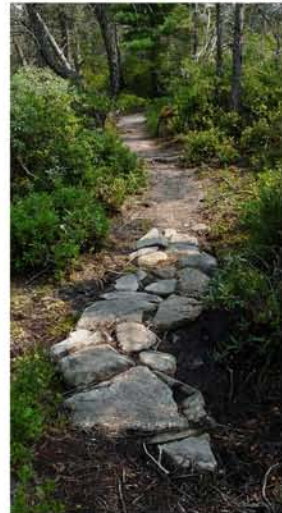
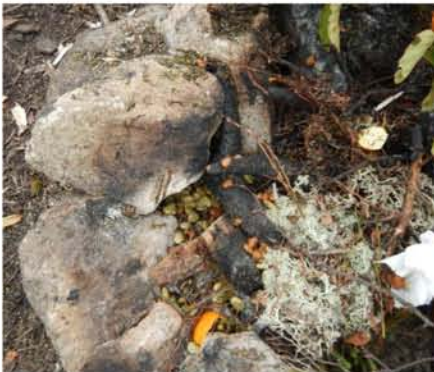
Fire pit with food waste Oct 2015

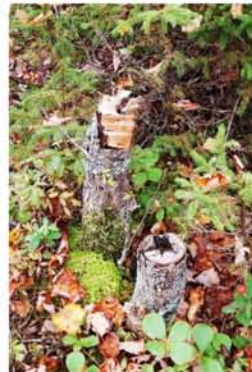
Newly chopped tree by old sawed tree
