**SANDY LAKE DEVELOPMENT
IMPACT ASSESSMENT
FINAL REPORT**

Submitted by:
Damon Conrad
Hany Sidhom
Steve Matthews

ABSTRACT

This report, created by senior Environmental Engineering students from Dalhousie University in 2001-02, involves the examination of Sandy Lake and surrounding area, in Bedford, Nova Scotia. Due to developmental pressures in the area from the major metropolitan area of Halifax Regional Municipality (HRM), Sandy Lake is of concern regarding its relatively undeveloped shoreline. The initiating factor of this report is a beach and park project to be developed by HRM, which started construction in 2001 and will be completed over the following few years.

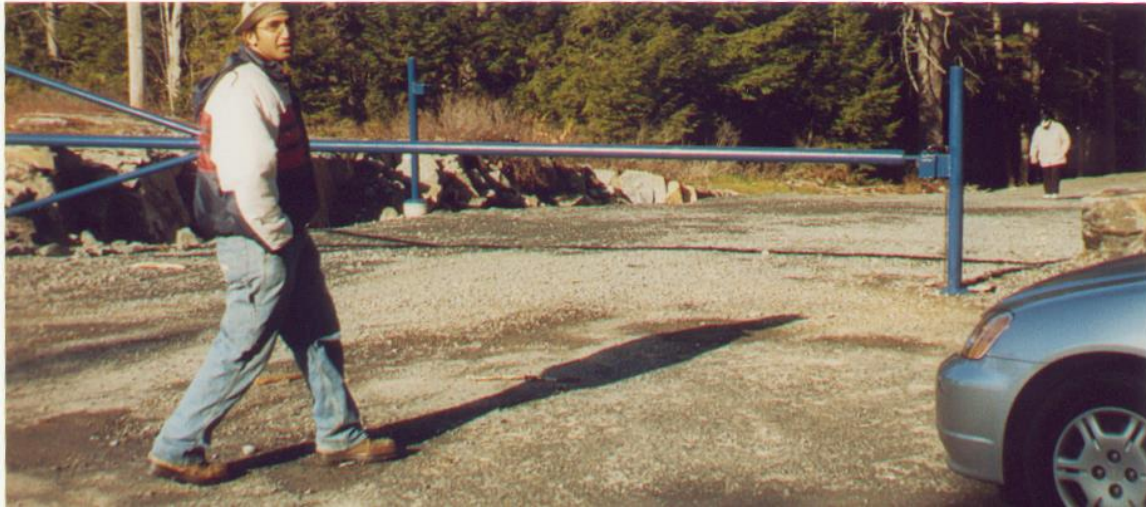
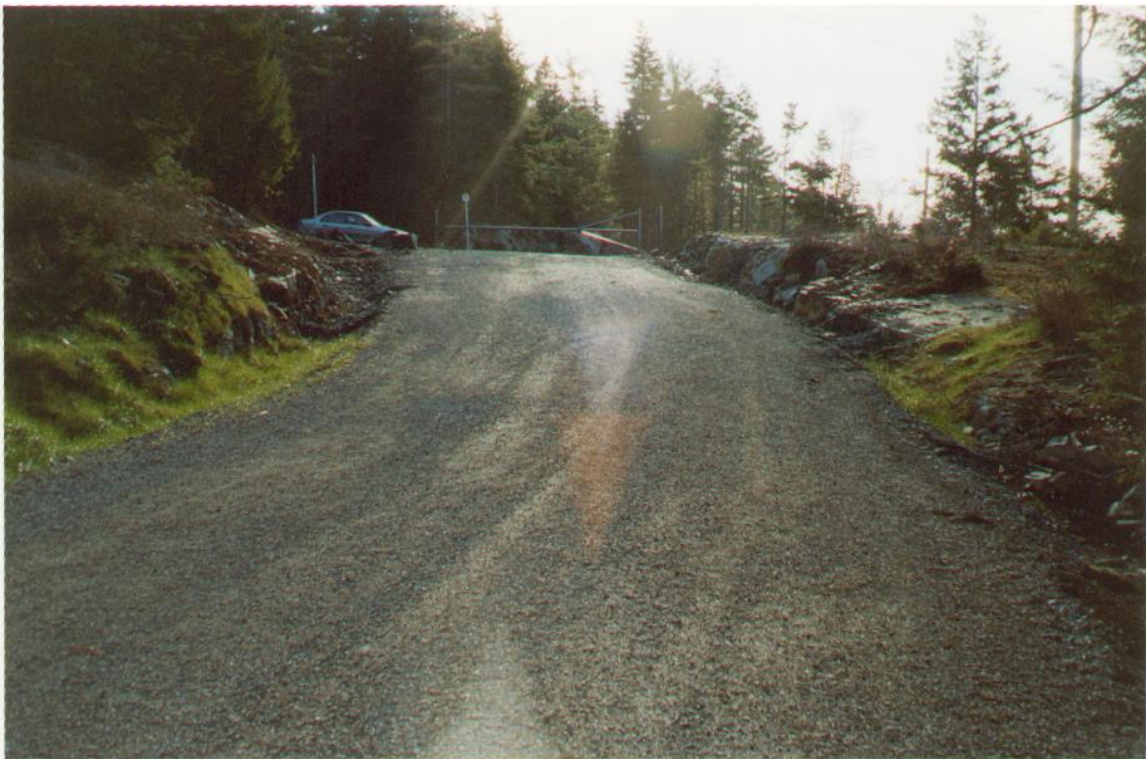
- 1) To examine the impact of Phase I (the construction of the gated road (Figures 2.2 & 2.3) and parking lot (Figures 2.4 & 2.5) for one hundred cars)
- 2) To examine the impact of developing a beach area with a capacity for 450 people
 - a. Impact on the aquatic life
 - b. Impact of the shoreline disruption.
- 3) To examine the impact on bio-diversity
- 4) To examine the impact on the water quality of the lake
- 5) To complete the bathymetric map, using data collected from first term
- 6) To establish baseline data for future reference
- 7) Computer modeling to determine the effects of increased residential development
- 8) Model runoff based on the universal soil loss equation

Figure 2.2 – Main gate on beach access road

Figure 2.3 – Access road to beach (looking up to the gate)

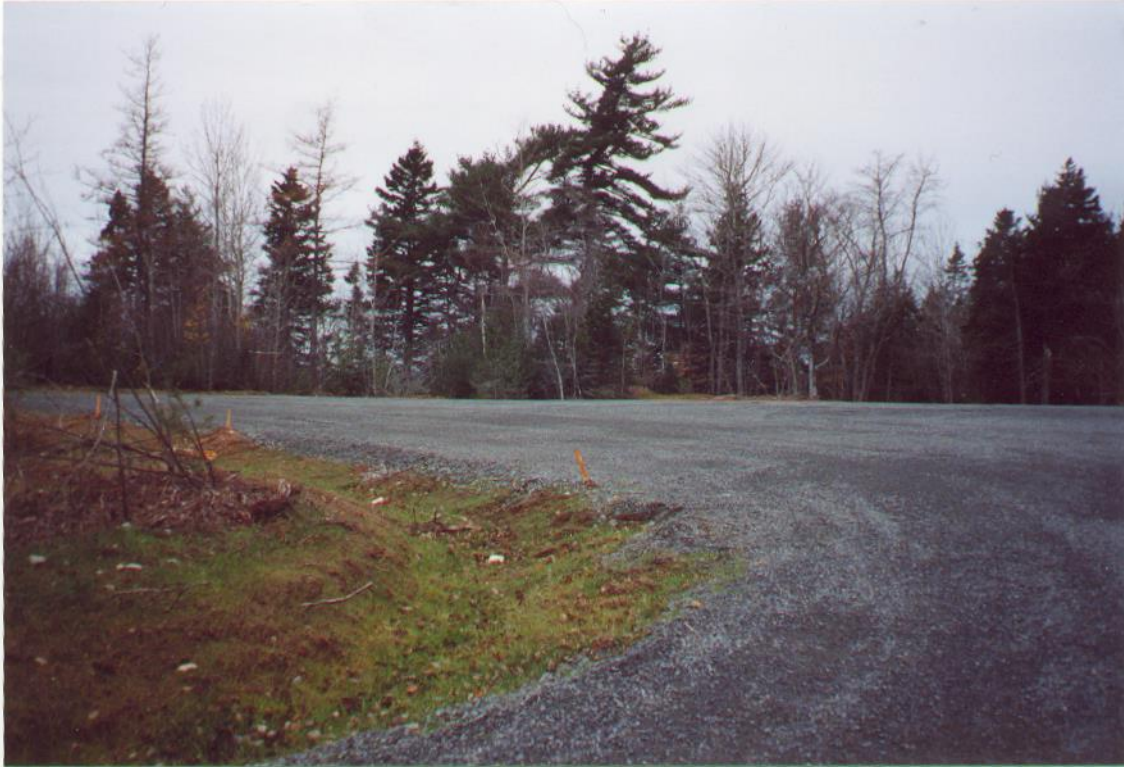
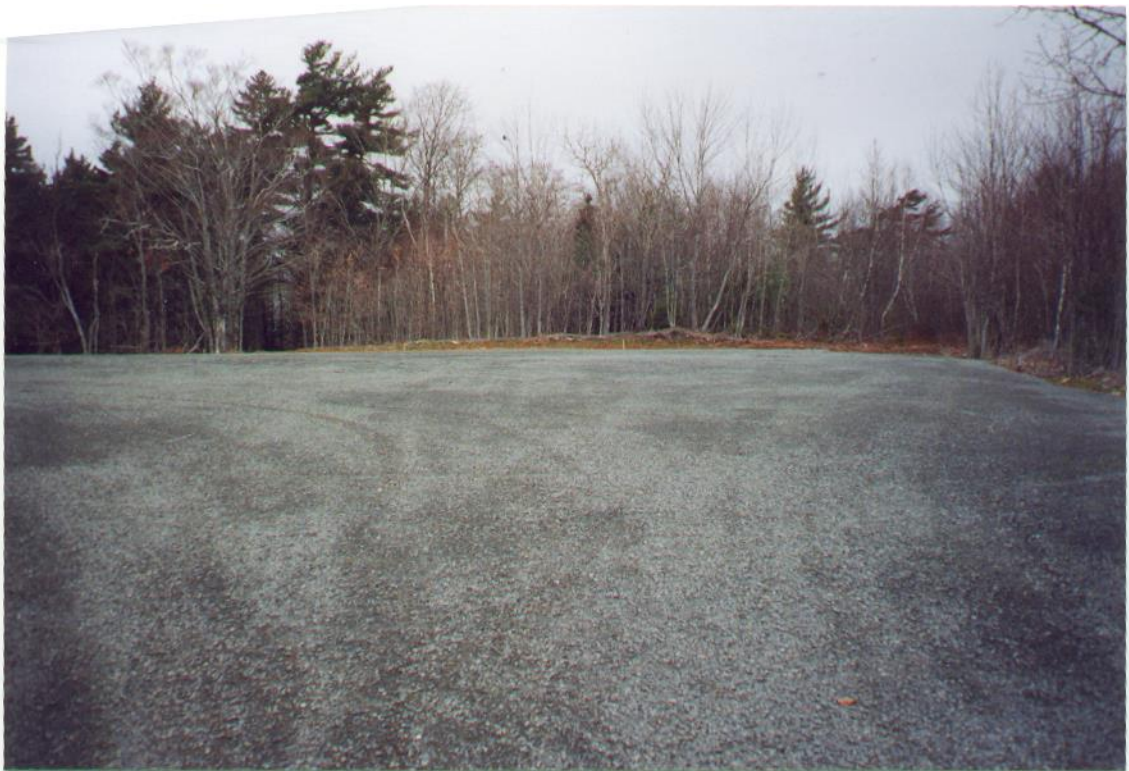
Figure 2.4 – Beach parking lot (west side)

Figure 2.5 – Beach parking lot (east side)

A parking lot has already been constructed, which is suitable for approximately 100 cars. No drainage system, such as tile drainage was put in place for this parking lot, even though there will probably be some contamination from leakage of oil and gas from the vehicles using the parking lot. This contamination was not considered to be of major concern by HRM and the developers since the parking lot is located at a fair distance from the lake.

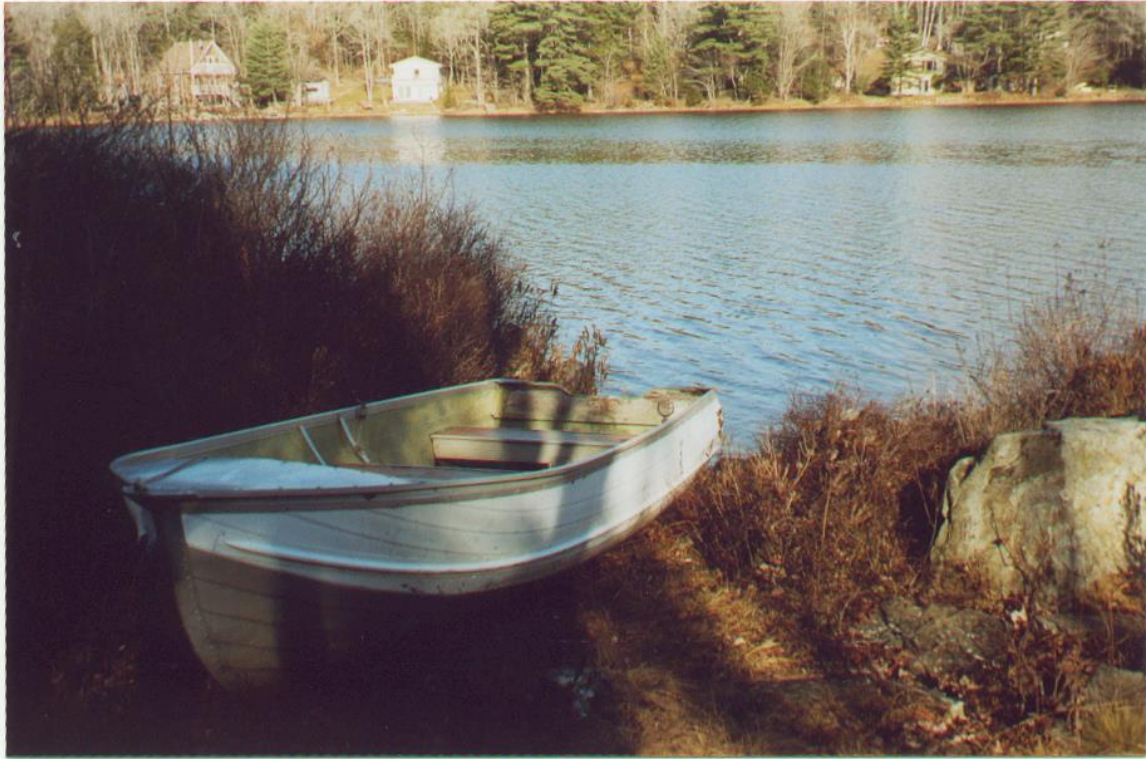
Figure 4.1 – The projects research vessel

Sampling sites were chosen from a map according to their importance to the project, located while on the lake, and referenced to a specific point on shore based on position and distance. Using the reference point on shore, the same site could be located during each sampling period with some degree of accuracy. Once the site was located, a stationary position was maintained using an anchor at the site and the boat (Figure 4.1) was pointed into the wind to prevent drift while testing.

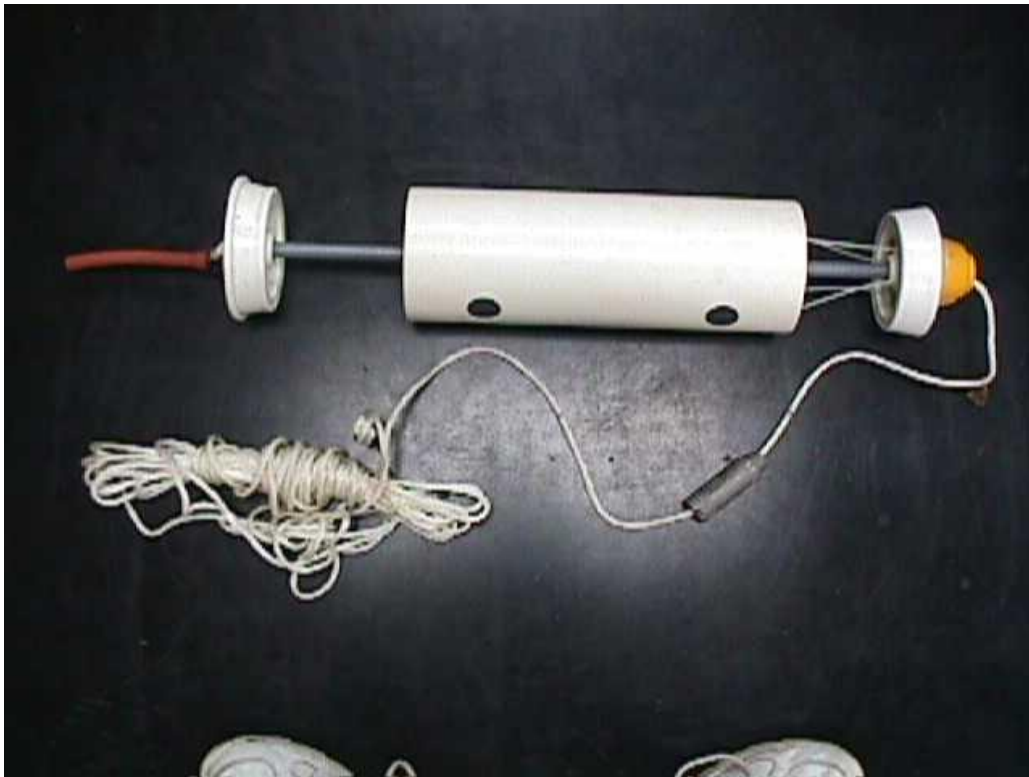
Figure 4.2 – Kemmerer – a device to take samples at depth

The surface samples were taken by hand, taking care not to contaminate the sample by placing nothing other than clean hands in the water while collecting the sample. The samples at depth were collected using a Kemmerer sampler (Figure 4.2), consisting of a hollow tube with valves at either end, which is attached to a rope with the depth in meters marked off on it. The tube with both valves open is lowered to the desired depth using the rope marks and a weight is dropped down the rope, which impacts the top of the tube, closing both valves. Only the water at this depth is collected, as the tube is open during the descent where water flows through it until the desired depth is reached. The tube then is pulled up and the water is retrieved from the tube via a small valve on the lower tube valve.

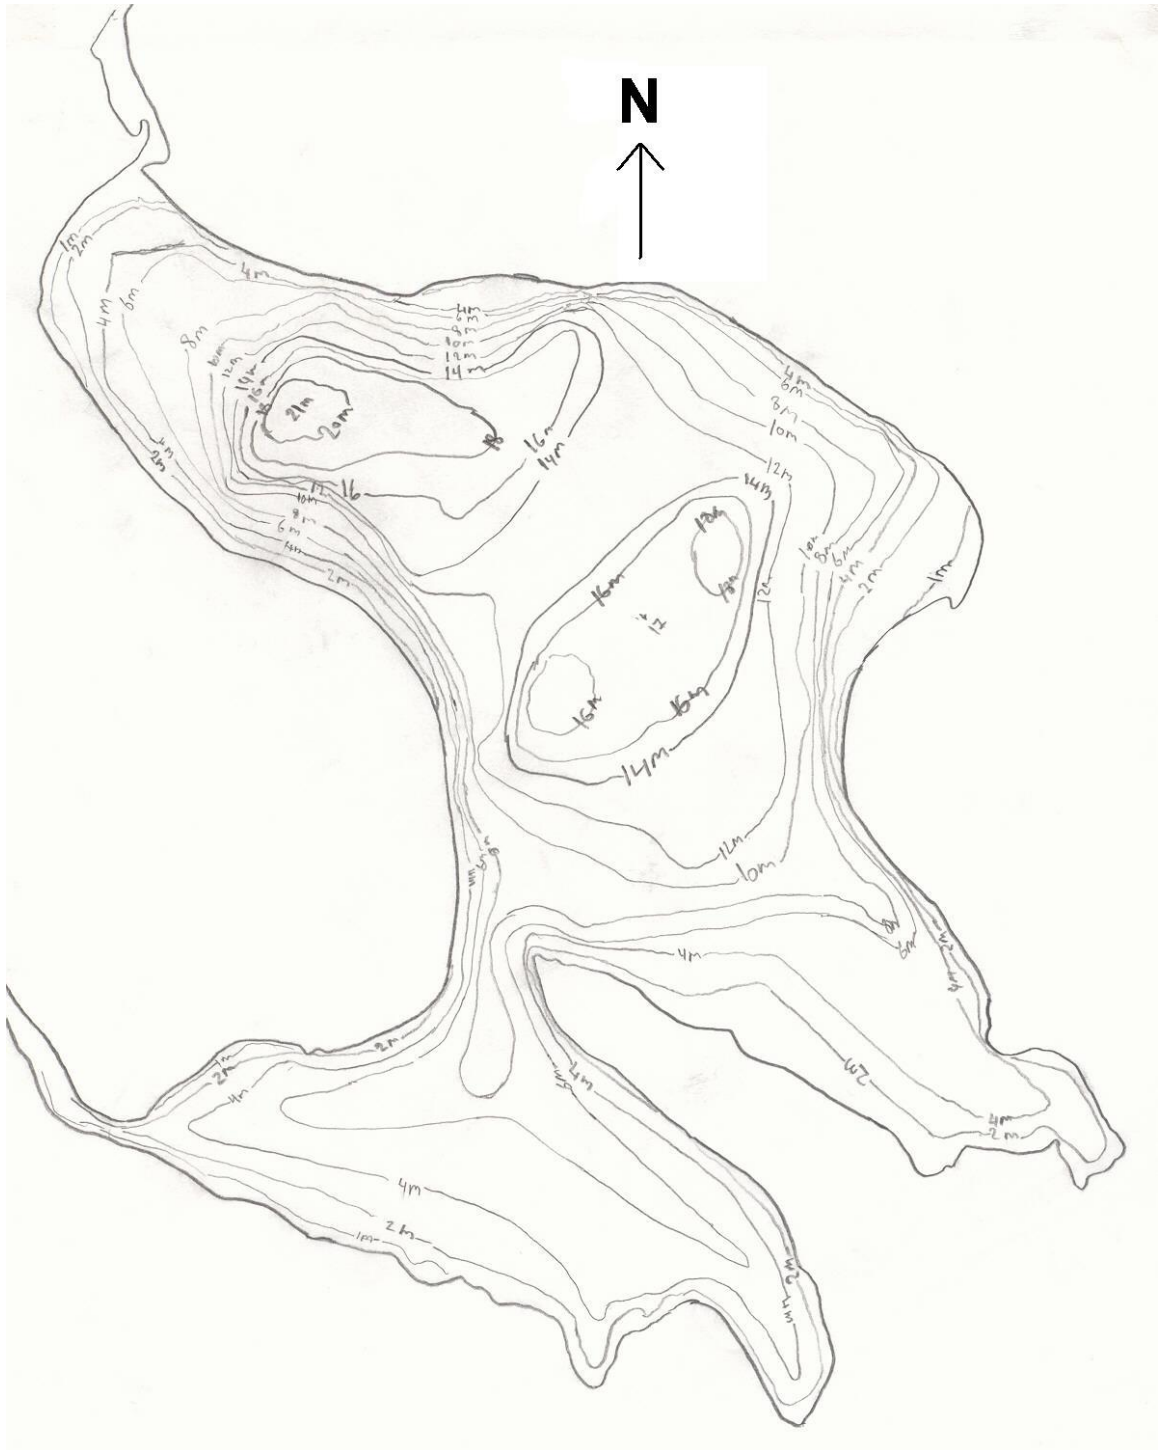
The bathymetric map (Figure 4.3) was constructed by running transects at equal intervals across the lake and measuring water depth along each transect. Transects were determined by selecting noticeable landmarks and then transferring these to a map from one point along a straight line across the lake to another point. For this project, sixteen transects were determined in order to properly cover the entire area of the lake surface.

Figure 4.3 – Bathymetric map of Sandy Lake

The final copy of the bathymetric map was done by tracing over the rough coping using a light table. The intervals for the bathymetric map ranged from 2 to 21 meters, and the deepest point was found to be 21 meters.

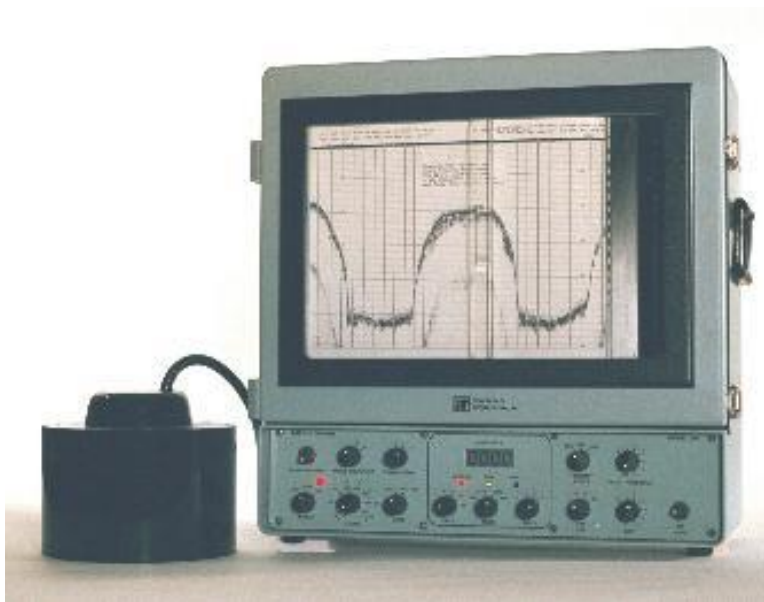
Figure 4.4 – Typical acoustic depth sounder (Innerspace, 2001)

Each transect was initiated at shore with a change to full throttle of the motor, accompanied by the starting of the depth sounder. As the transect progressed, one team member (the driver) maintained the heading appropriate to reach the preordained point on the other side of the lake while another group member, the operator, ensured proper and accurate operation of the depth sounder by altering the scale of the trace created by the sensor to ensure that the trace did not exceed the span of the paper recording. During each transect, the operator made note of each scale change, transect number, and direction traveled on the trace while the third member, the navigator, watched for obstacles, determined course, and made notes of activities.

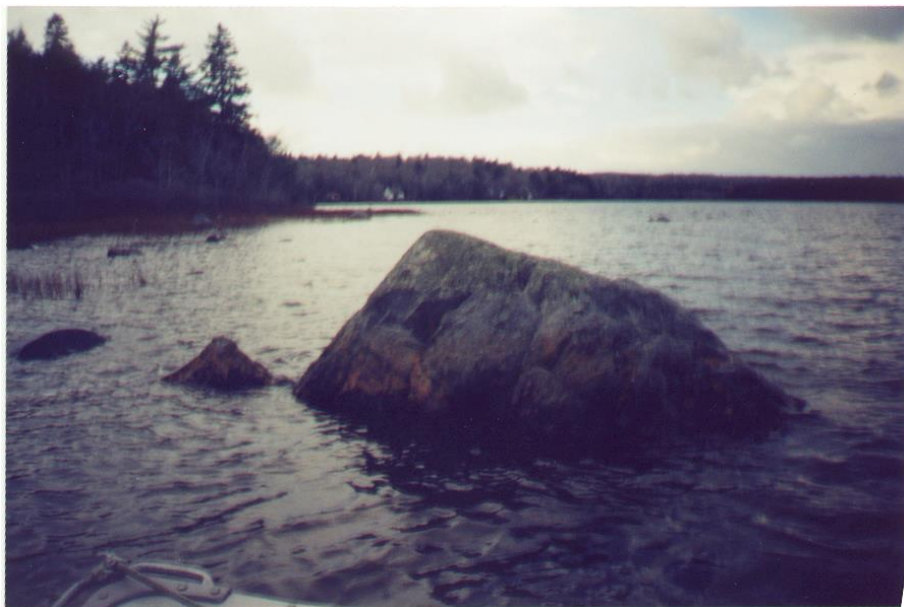
Figure 4.5 – Rock used for water depth reference at the time of mapping

Before leaving the field, the lake was searched for a recognizable landmark in the water (a permanent dock or rock – a rock in this case) to use as a point of reference to allow compensation for any change in water depth from season to season and year to year. A rock (Figure 4.5) was chosen which was large enough to be not moved around by the winter ice and was recognizable for future studies. The location of this rock can be found on the map in Figure 2.1. This rock had a vertically flat face, which made its peak easy to measure above the water line. This distance was measured, recorded, and the rock was referenced to a point on land, described, and several pictures were taken to ease locating this point in future depth profiles. At the time of depth sounding, the reference rock was 90cm above the water level.

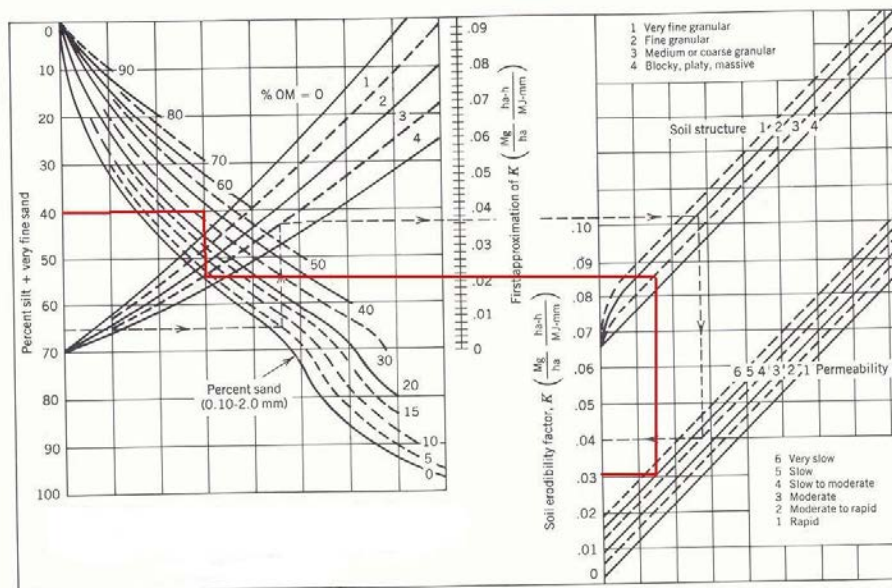
Figure 4.6 – Process for determining the K value in the USLE equation (Schwab, G, et al. 1993)

- R value based on geographic location – Halifax
- K value estimated from Figure 4.6, using 25% gravel, 35% sand, 40% silt and clay, 3% organic matter, fine granular structure, and slow permeability (MacDougall & Cann, 1963)
- L value using a slope length factor of 45m, and field slope steepness of 1.7
- S value using a slopes longer than 4m and a field slope percentage less than 9%
- C value based on ground cover resulting from project
- P value based on common practice

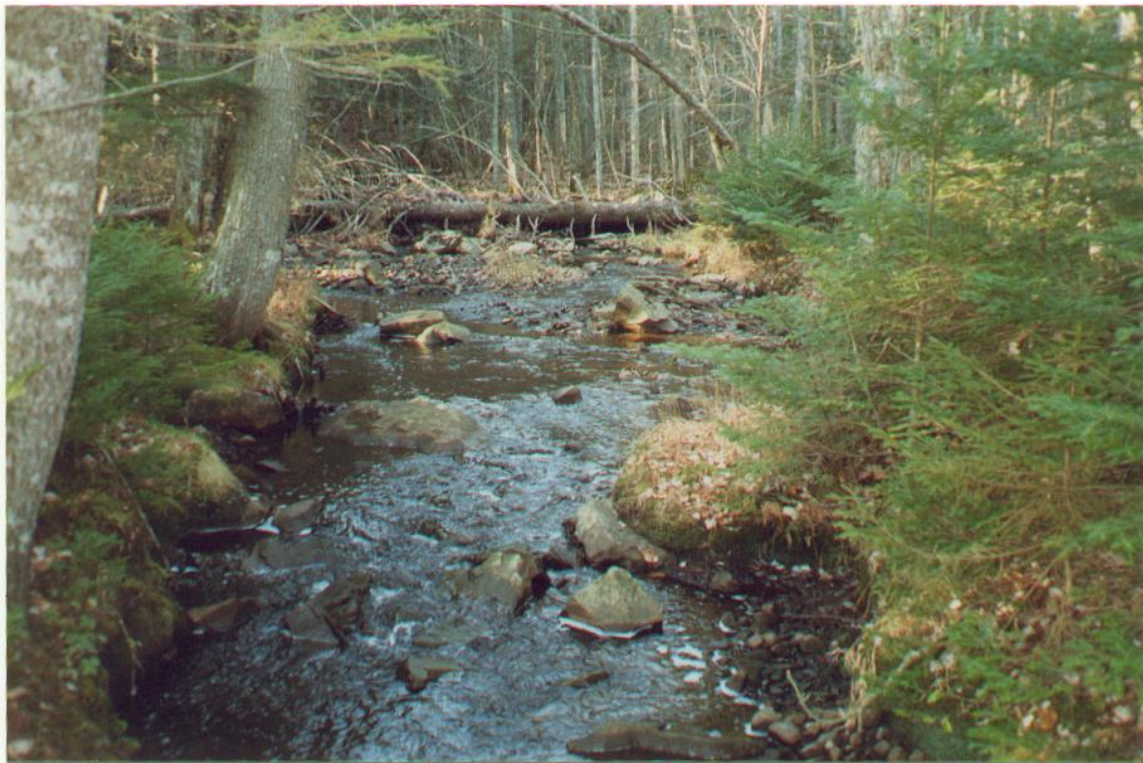
Figure 6.1 – Northern Inlet

Sandy Lake is fed by two main inputs, the first being a small stream (termed the Northern Inlet (Figure 6.1) entering the lake from the north, the second being a small river entering the lake from the south through the southern inlet. The lake is drained through the outlet on the north end (Figure 6.2), just east of the Northern Inlet. We suspect that much of the flow from the Northern Inlet “short-circuits” the lake by flowing directly across to the northern outlet and leaves the lake, with relatively low impact.

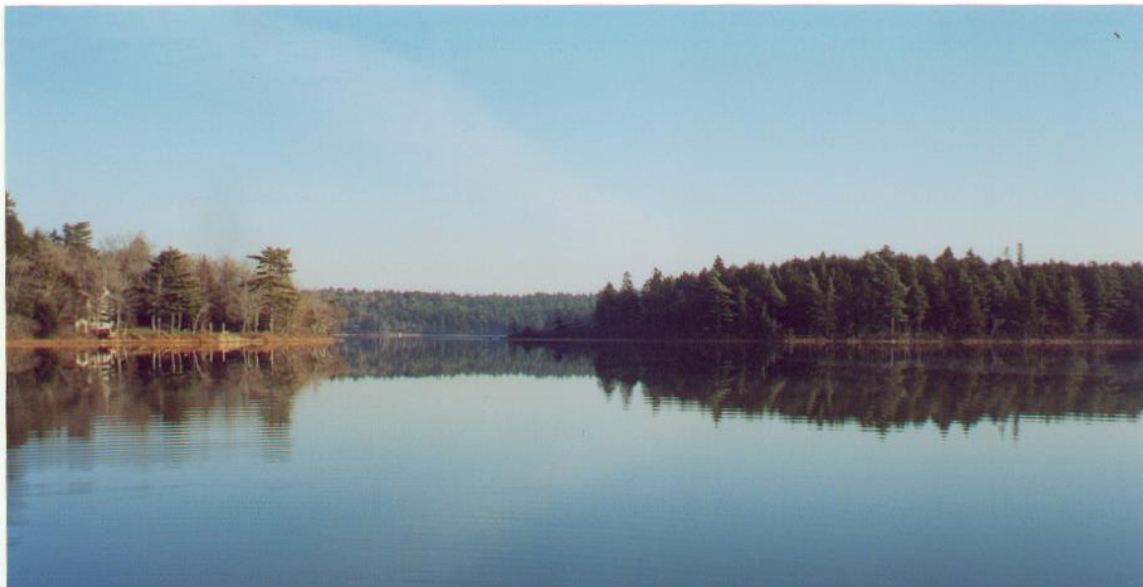
Figure 6.3 – Narrows of Sandy Lake

The lake is made up of two smaller basins separated by a narrow, relatively shallow shelf (Figure 6.3), which divides the lake into a northern basin (Figure 6.4) (deeper and larger, and a southern basin (more shallow and smaller).

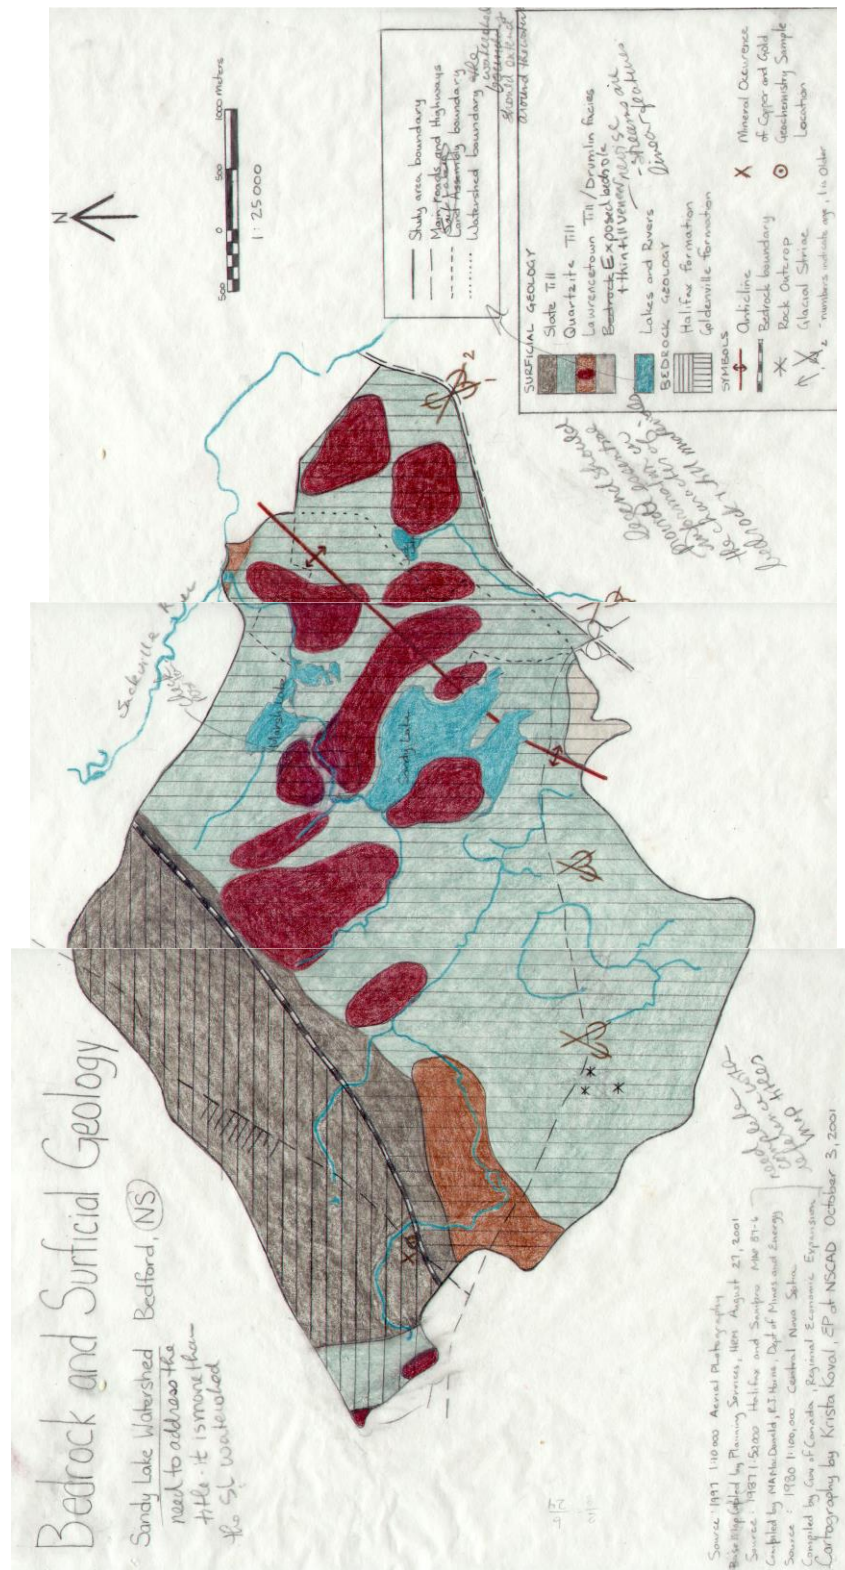
Figure 6.5 – Geological survey of Sandy Lake watershed (Koval, Krista, 2001)

Acid drainage results when pyrite-bearing rock is exposed, and reacts with air and water, creating sulphuric acid and dissolved iron (<http://geology.er.usgs.gov/eastern/environment/drainage.html>). This type of exposure usually occurs during mining and construction activities. Sometimes pyritic rock is left uncovered after construction activity is finished, resulting in continuous drainage of acid. A region found in the northwest region of the Sandy Lake Watershed is underlain with slate, and some of this slate has been exposed. A small brook that originates near this exposed slate, and empties into Sandy Lake, has a pH of approximately 3.4, and leads to suspicions that the exposed slate may be pyritic.

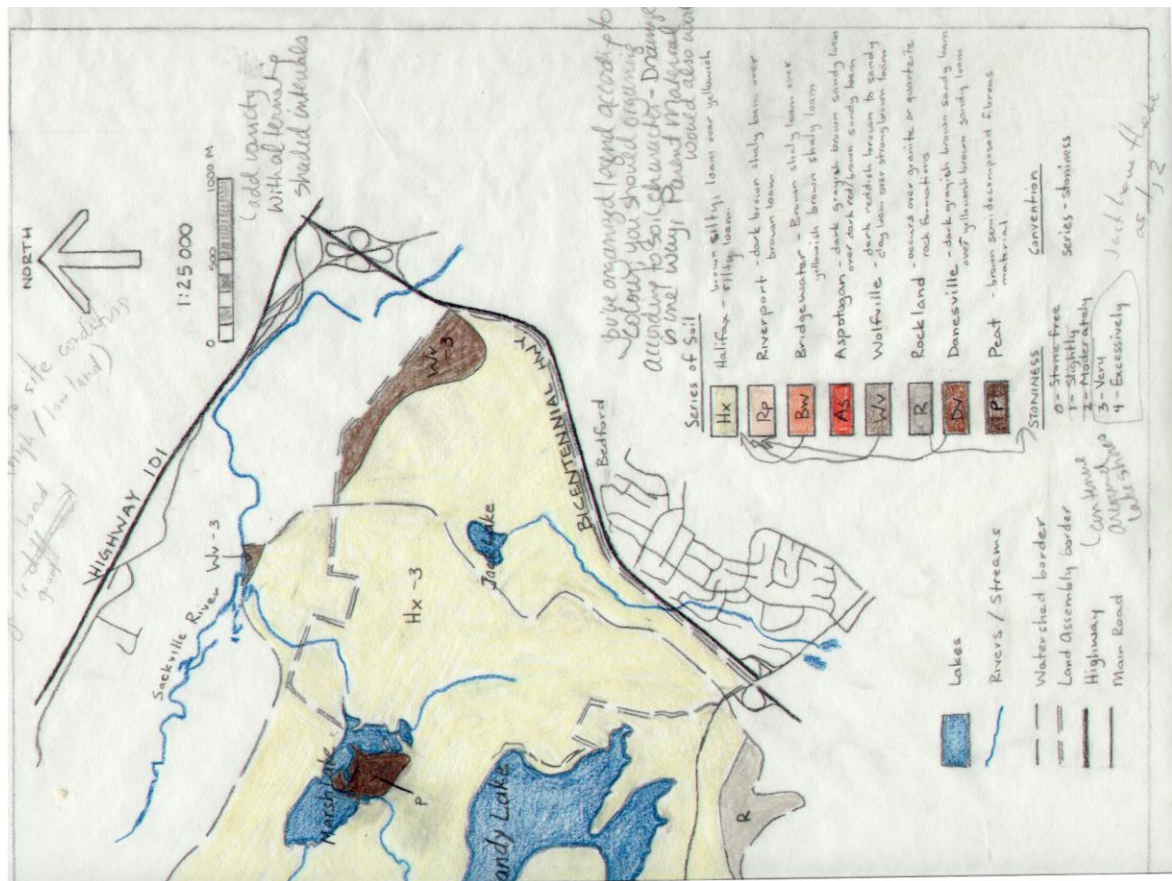
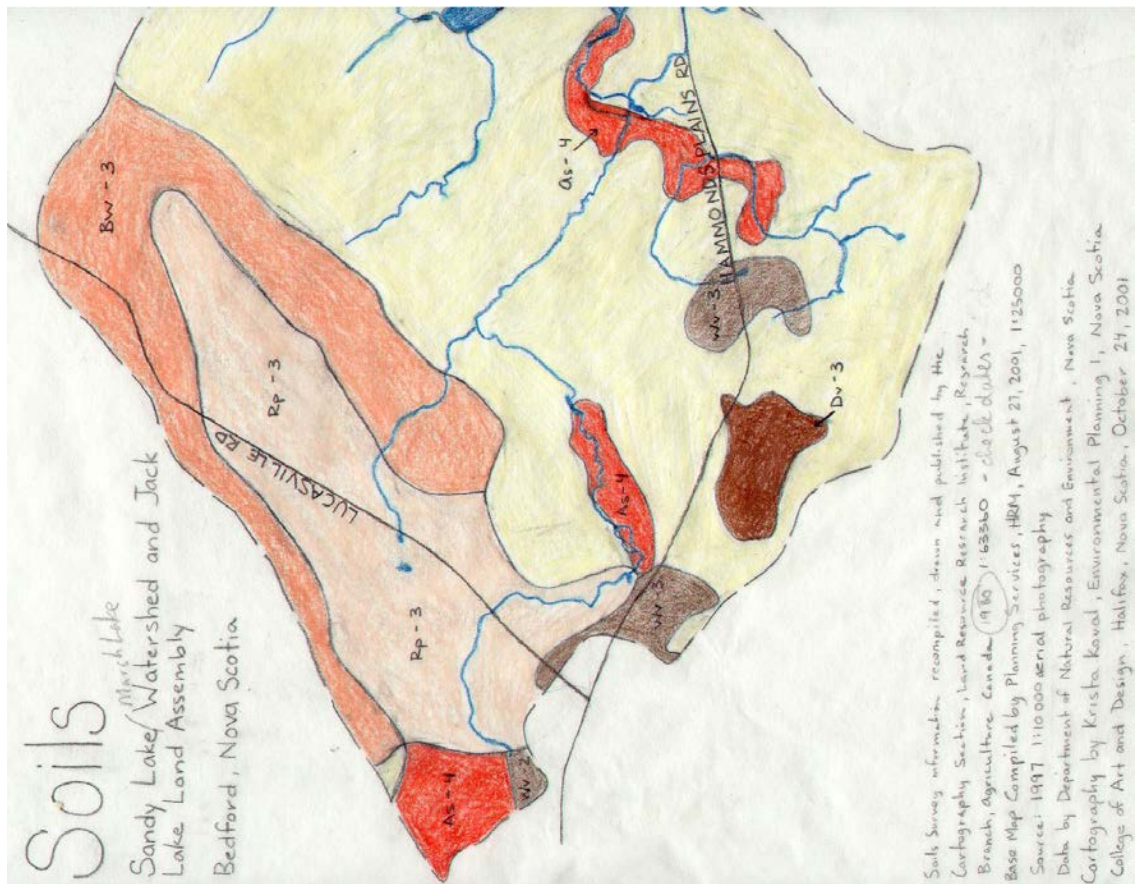
The region around the lake is comprised of mostly Halifax soil, which is a sandy loam type of soil (Figure 6.6). Aspotogan soil surrounds the southern inlet, the inlet by Farmers Dairy. The area where the northern outlet from Sandy Lake enters Marsh Lake is comprised of peat. Overlying the slate region in the northwest corner, two other soil types are found, Bridgewater and Riverport.

Figure 6.6 – Soils type in Sandy Lake area (Koval, Krista, 2001)

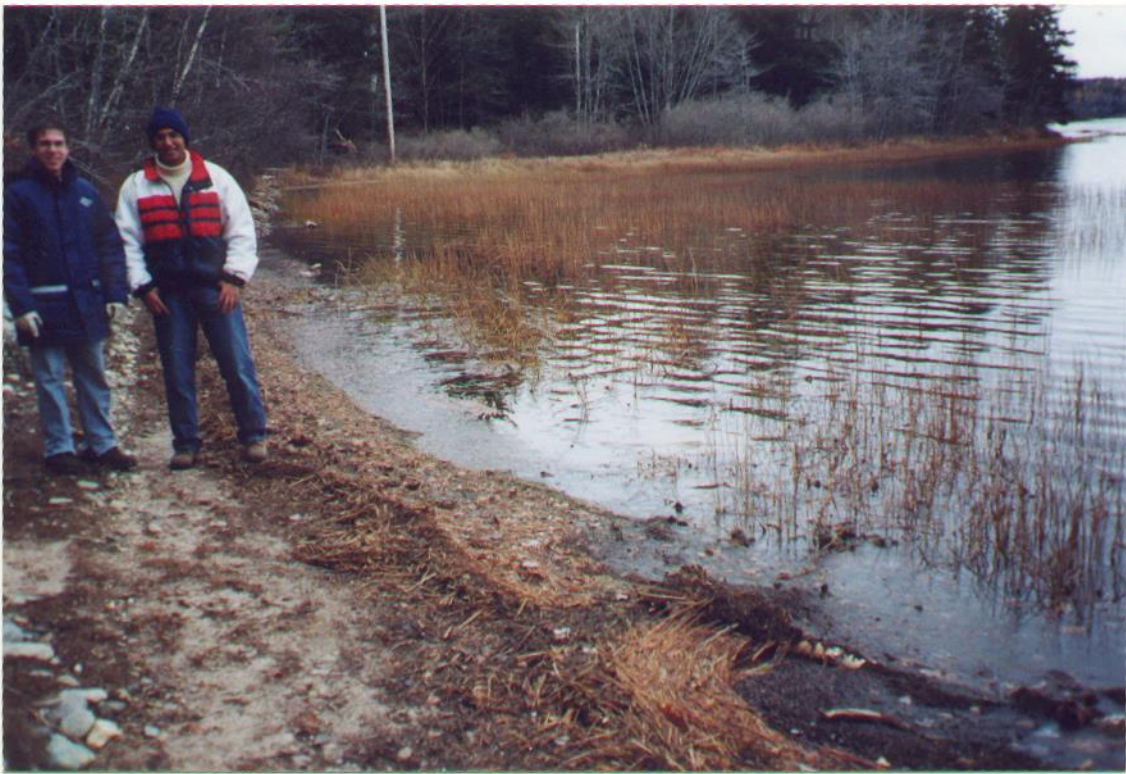
Figure 6.11 – Natural beach zone at proposed site

The beach is proposed for construction on land with a slope in the 0-5% range. There is a region of natural beach (Figure 6.11) approximately 1 meter wide, depending on water level, from the water edge to the riparian zone (Figure 6.12). The riparian zone is made up of a combination of hardwood and softwood trees, such as fir, birch, and pine. Also, growing in the shallow waters next to the shore is a large amount of vegetation (Figure 6.13). This region has been described as a low energy site (low fertility) in the lake that is an important component of the fish habitat (Hamilton, 2000).

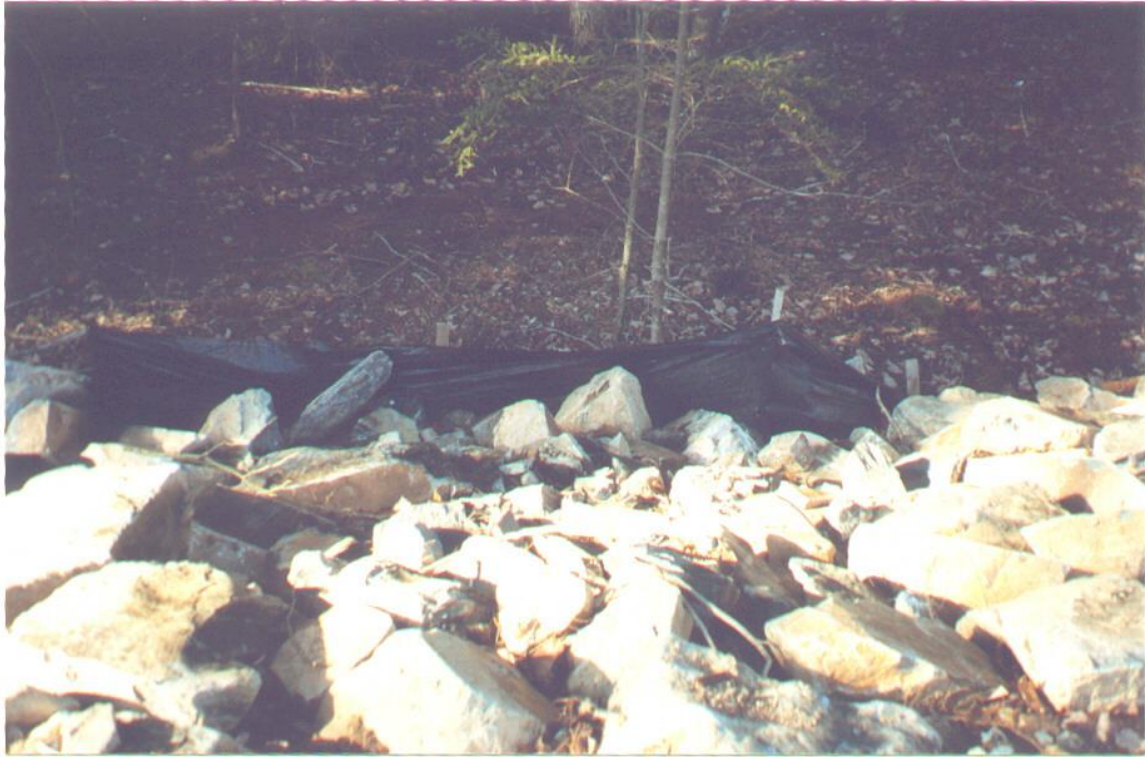
Figure 6.14 – A silt fence in use off the beach access road

Before any construction takes place along the shore, silt fencing will be put in place to reduce the amount of silt entering the lake. This fence will be placed along the edge of the high water mark. A silt fence, seen in Figure 6.14, is currently in place along the access road to the parking lot. Another form of silt control is achieved through the use of hay bales (Figure 6.15) across small streams to control the movement of silt but allow the passage of water; however the effectiveness of this control is in question (Schwab et al, 1993).

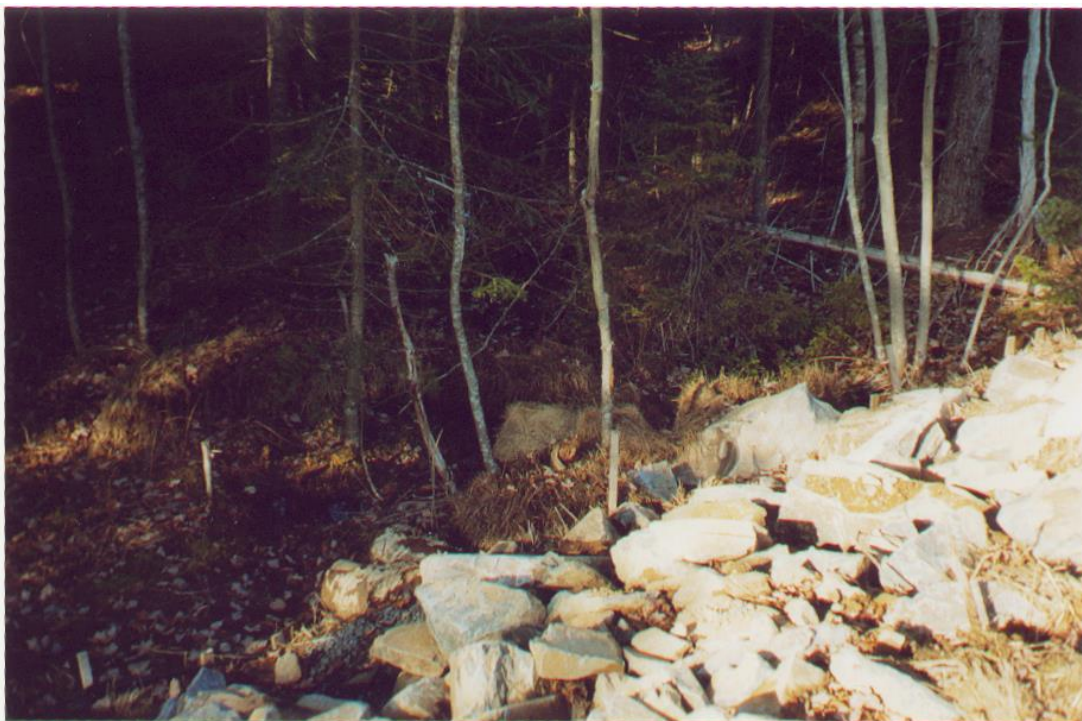
Figure 6.15 – Hay bales (middle) in use off of beach access road in a small stream

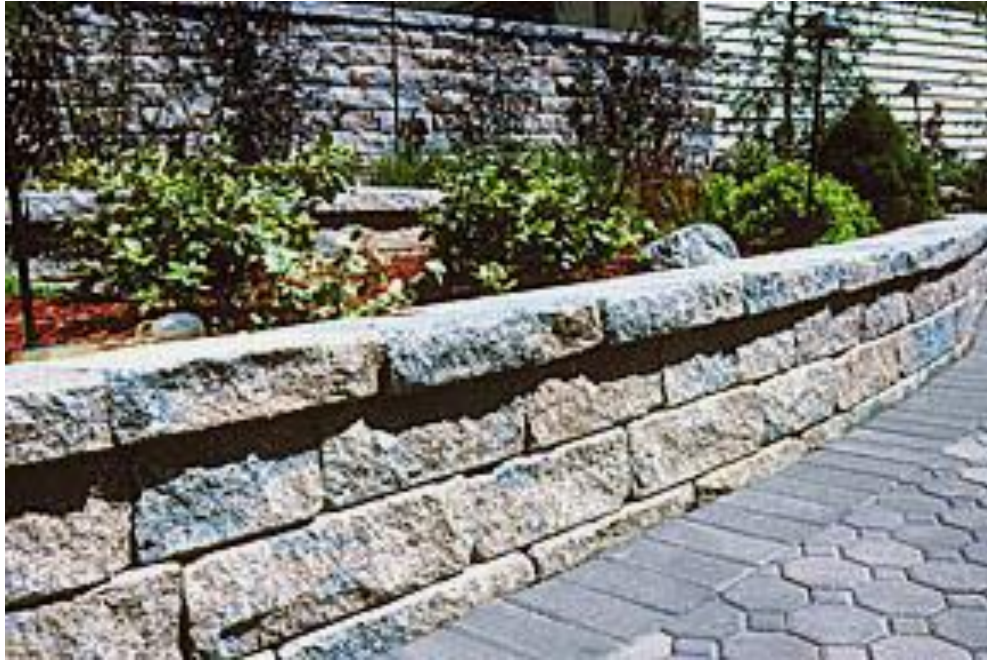
Figure 6.16 – A common stone retaining wall (<http://www.paveloc.com/largecreta.html>)

No construction is allowed to take place below the high water mark (HWM). A stone retaining wall, similar to the one in Figure 6.16, is to be constructed above the HWM that will separate the deposited sand at the beach from the natural beach. The wall is to extend 18 inches below the finished grade. At the base of the wall a 4-inch diameter sock filter (Figure 6.17) will be put in place. The imported sand will be deposited behind this wall. Under the deposited sand will be a geotextile fabric liner (Figure 6.18) to prevent sediment transport to the natural beach.

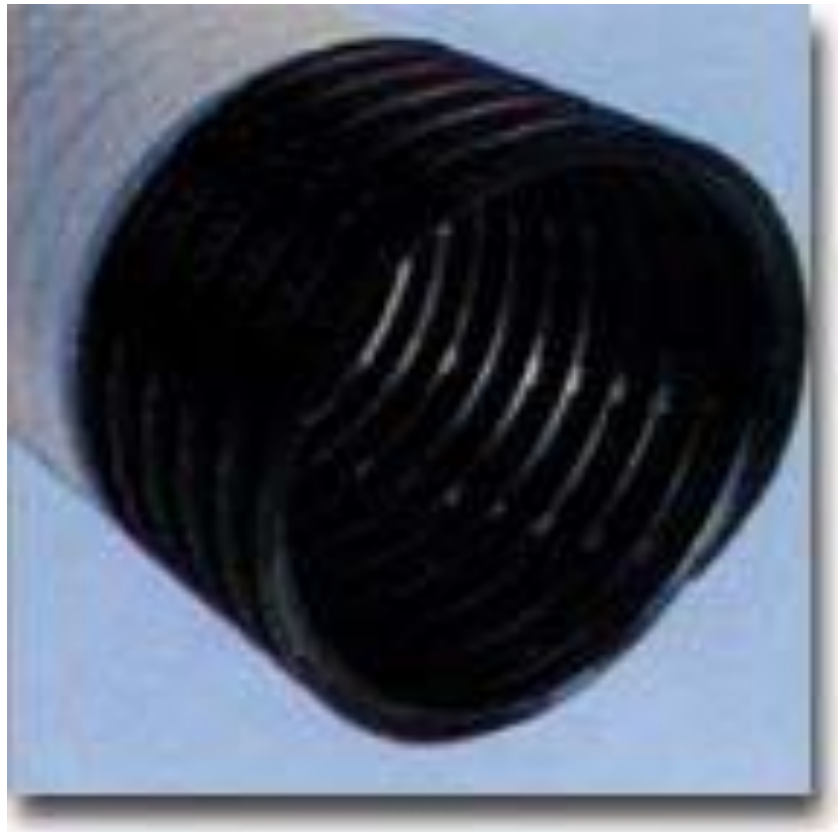
Figure 6.17 – A typical sock filter (Armtec Ltd. 2001)

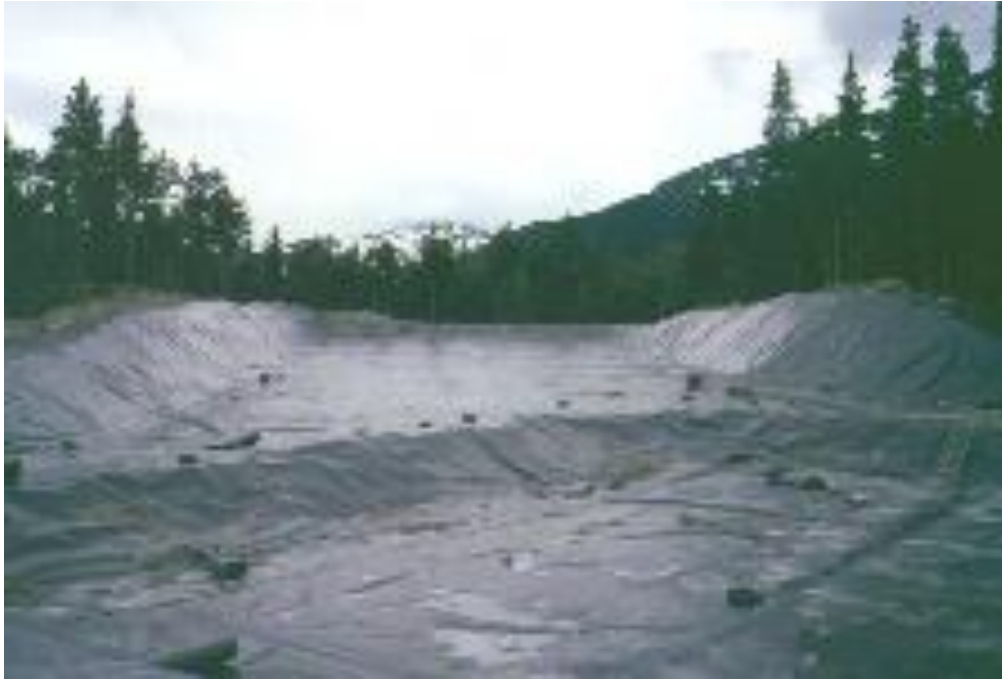
Figure 6.18 – A common geotextile fabric liner used in construction

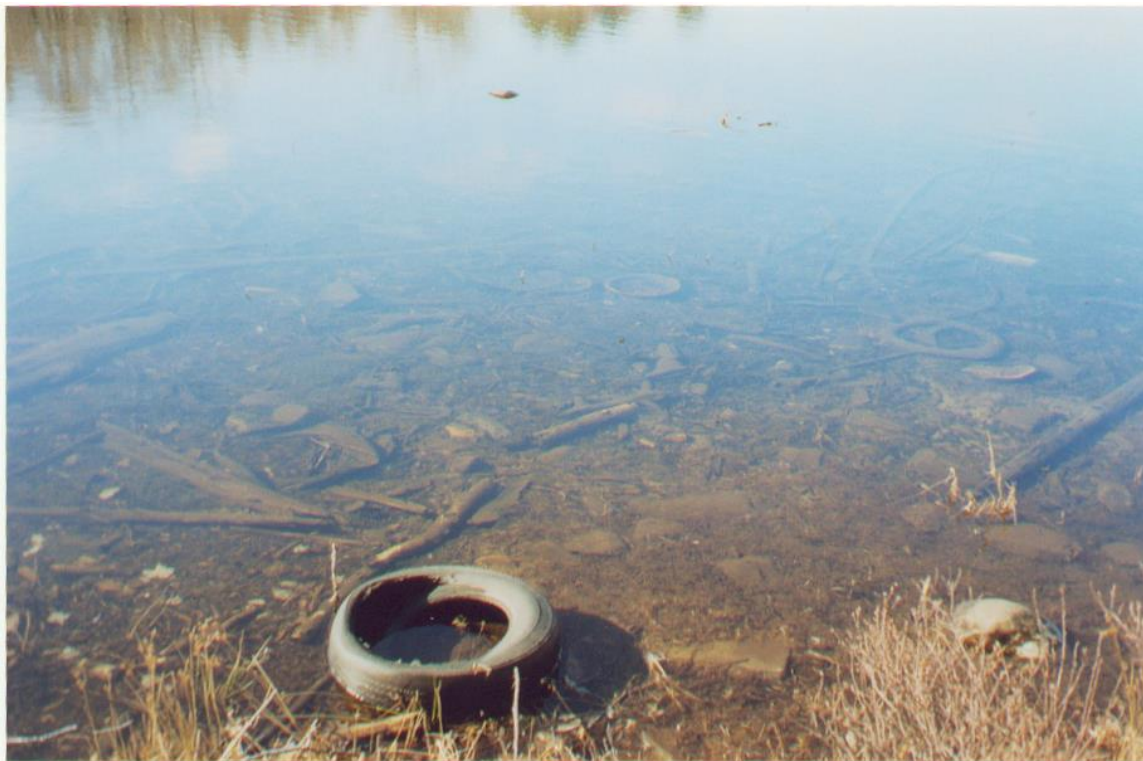
During numerous visits to the Sandy Lake area, common litter problem have been noticed. A wide variety of garbage, such as tires (Figure 6.19), rusted metals, car parts (Figure 6.20), and oil traces were found in and around the lake. A major concern with higher numbers of visitors to the region is the possible increase of garbage left in the area, often associated with human traffic.

Figure 6.19 – Tires and various car parts found in southeast section of Sandy Lake

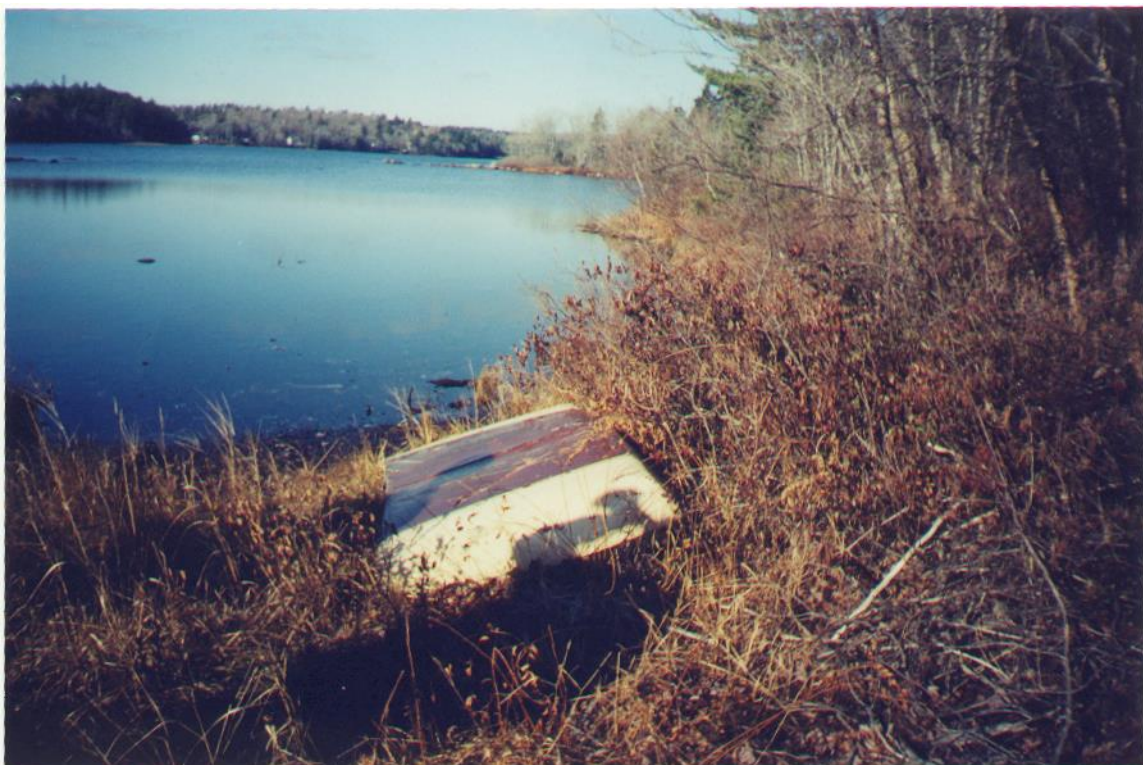
Figure 6.20 – Truck hood found on shore in southeast region of Sandy Lake

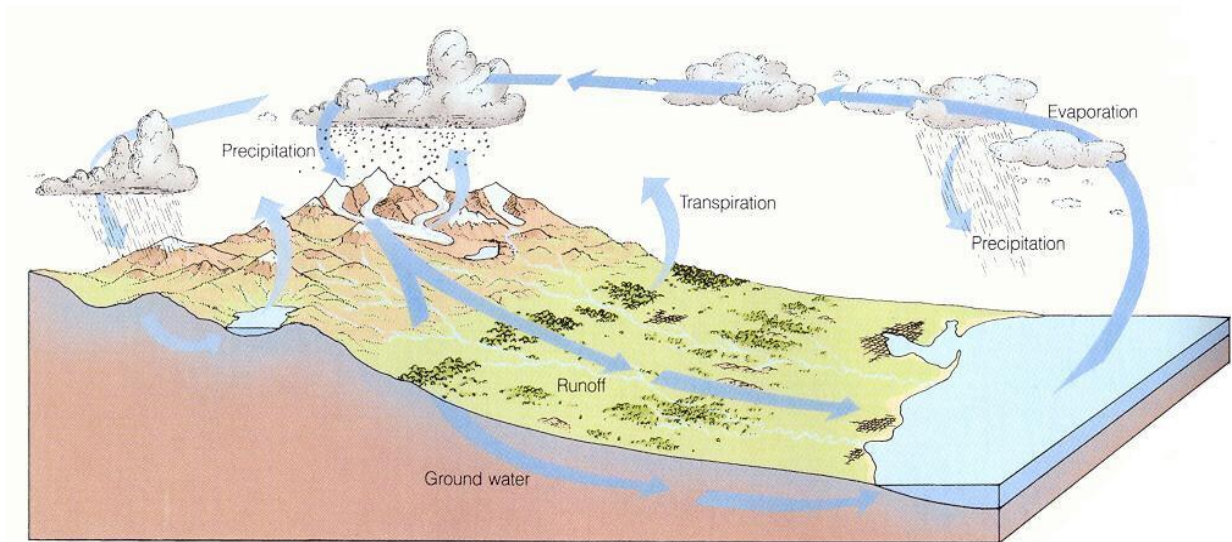
There are five major processes that make up the hydrologic cycle: condensation, precipitation, infiltration, runoff, and evapotranspiration. Figure 6.21 shows the stages of the hydrologic cycle.

Figure 6.21 – The Hydrologic Cycle (Hamblin, Kenneth W., 1992)
